**MINUTES OF A COUNCIL WORK SESSION
HELD IN THE COUNCIL CHAMBERS
JANUARY 11, 2012**

Re: Santaquin Winter Storage Pond #1 Discharge Incident

Exhibit A

Pictures documenting flow path of discharged effluent water

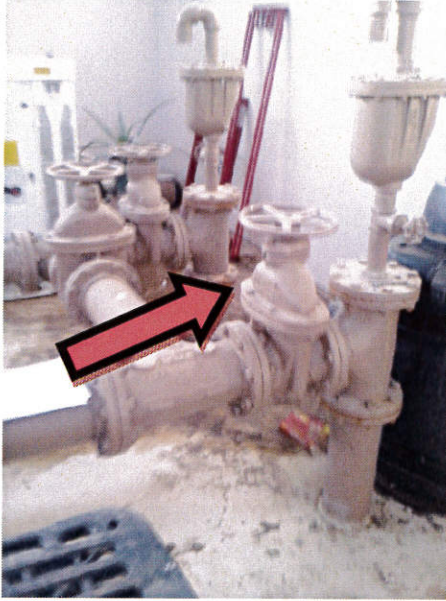
Upon arriving at the sewer lagoon facility, Mr. Eva found that water was in fact being discharged from the winter storage pond via gravity flow. Mr. Eva had found that the valve that allows for the normal and proper discharge of sewer effluent to our alfalfa fields during the regular irrigation season had been tampered with and opened.

Sewer Effluent Discharge Valve

- As soon as it was discovered that water was discharging from winter storage pond #1, the valve was turned off; thus stopping the flow of water.
- Santaquin City immediately contacted the Utah Division of Water Quality to verbally notify your office of the incident.

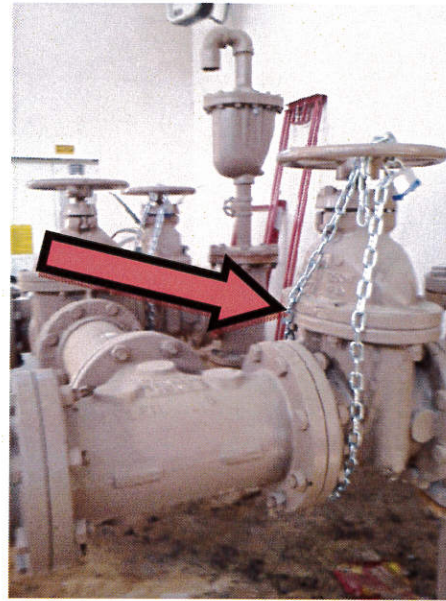
Locked Valves

- Police Chief Dennis Howard was asked to open an investigation of the vandalism.
- Mr. Eva established a building security policy which requires that the sewer pump house remain locked at all times. In addition, chains and locks have been added to the valves to insure that they could not be opened in the future even if unauthorized access to the sewer pump house occurred.

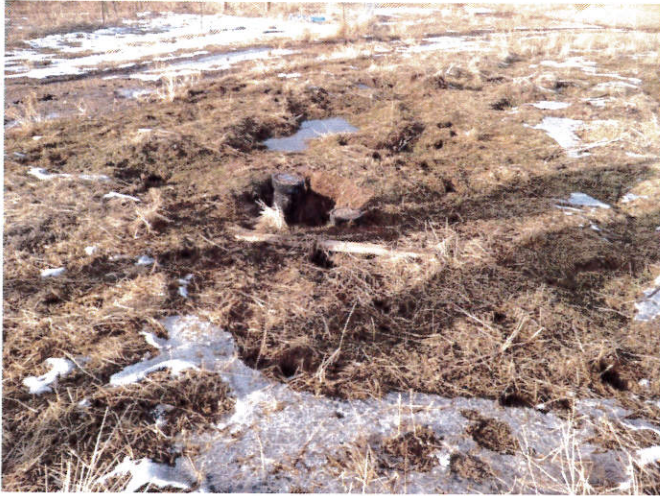
Looking north toward Drain Valve where discharge occurred. (Santaquin City Property)

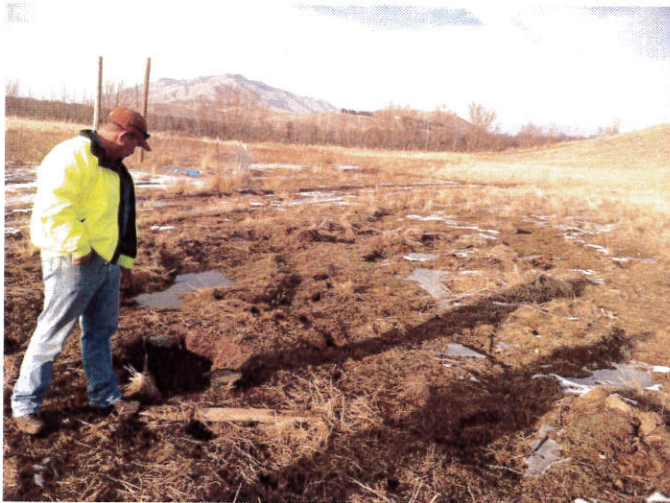
Looking north along flow path and saturated area around discharge point.

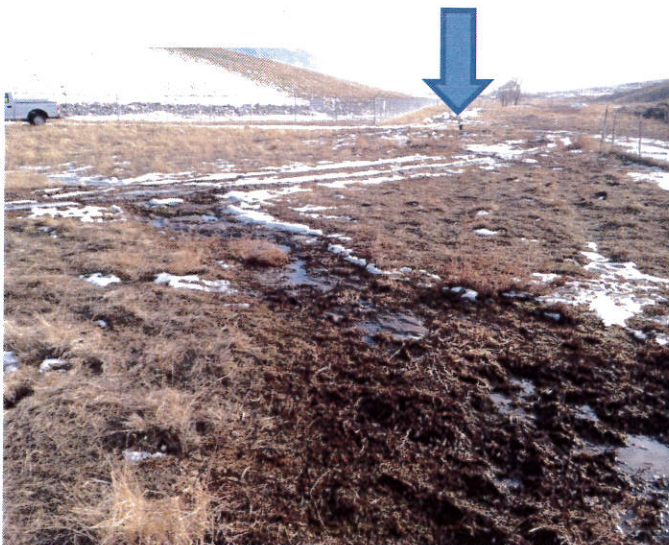
Looking south along flow path toward discharge point (noted by arrow).

No visible running water. Pooling "wet" spots in picture are remnant ice patches. (Approx. 150 feet From Discharge Point (FDP)).

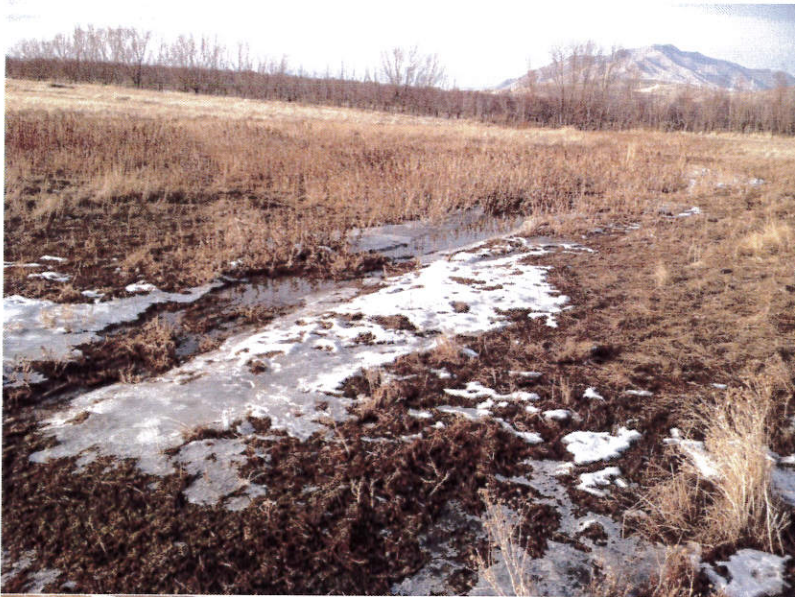
Looking north along flow path
(approximately 150 feet FDP) near
the point where discharged flows
entered natural runoff channel.

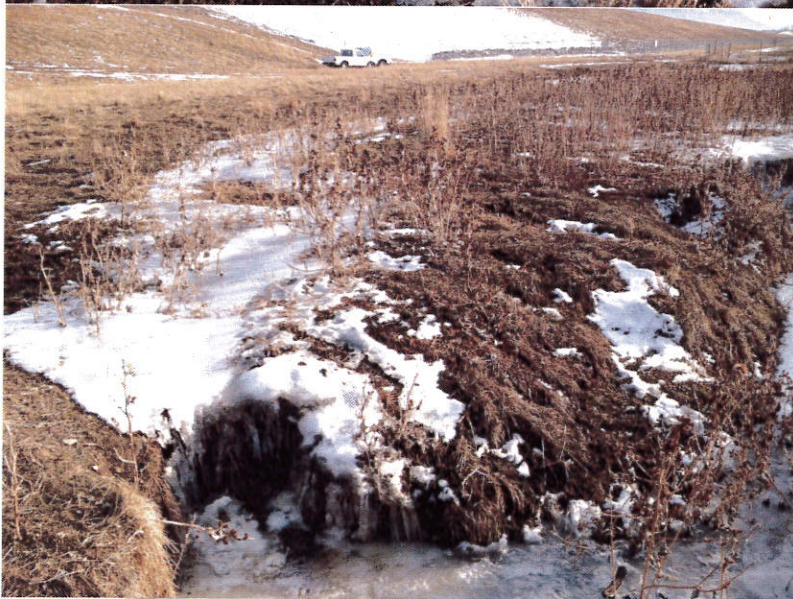
Looking south from intersection of
discharge flow path and natural
runoff channel. (Winter storage
pond #2 embankment in the
background)

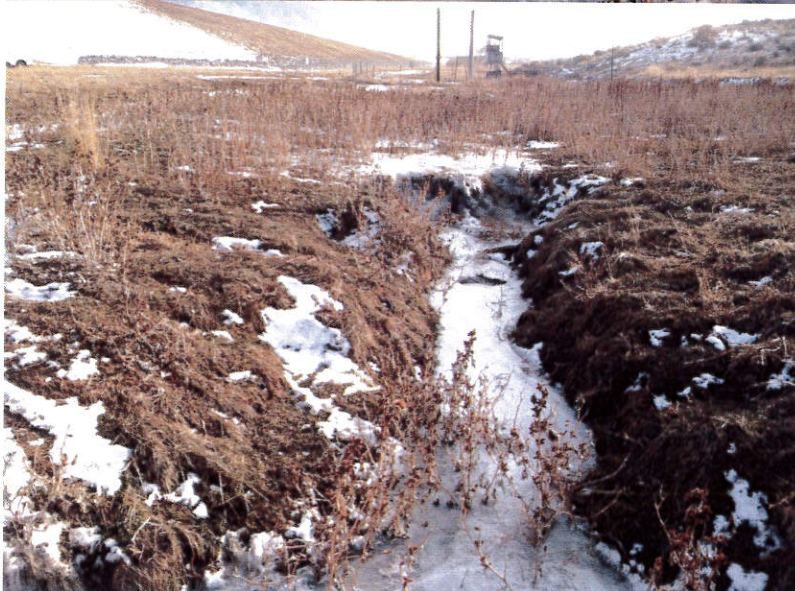
Looking south along natural runoff
channel (210 feet FDP)

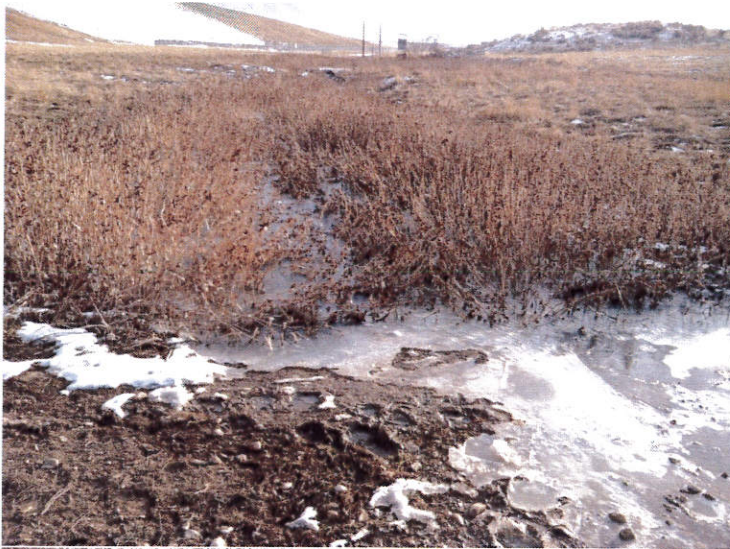
Looking south along flow path (approx.. 400 feet FDP). Intersection of natural channel and farm road on Santaquin property.

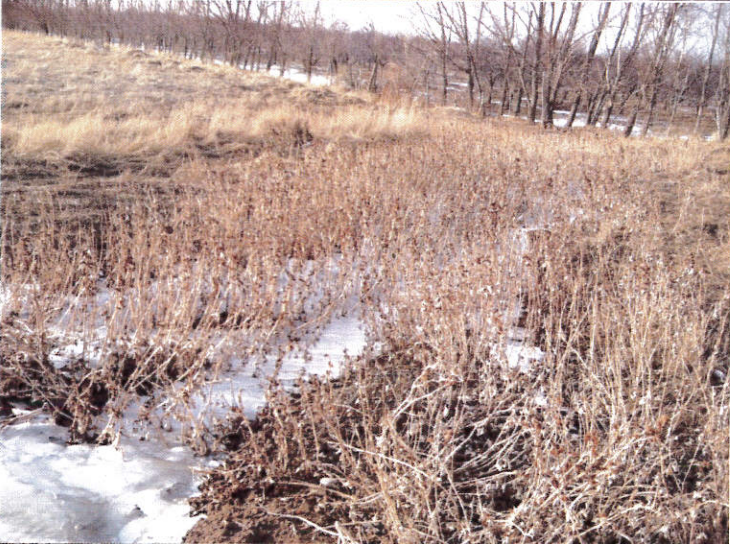
Looking northwesterly from farm road. Natural channel course running toward north Santaquin property line and Rowley's South Ridge Farms property.

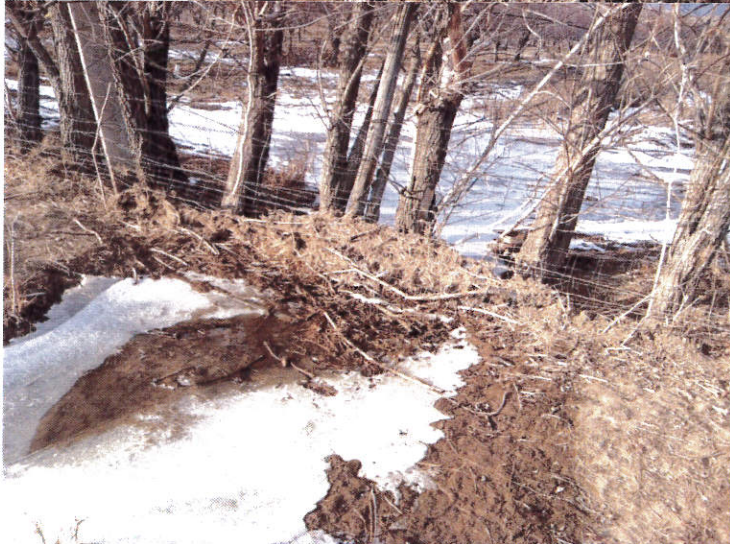
Santaquin side of fence line where discharged flows entered onto Rowley's South Ridge Farms property. (Approx. 485 feet FDP)

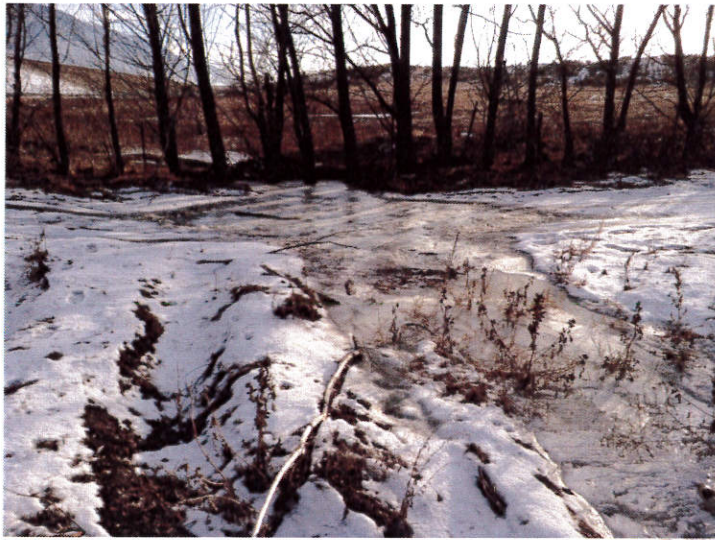
Looking south toward fence line and along flow path. (Rowley's South Ridge Farms property at approx. 530 feet FDP) Pooling "wet" spots in picture are remnant ice patches with some small, isolated pooling areas.

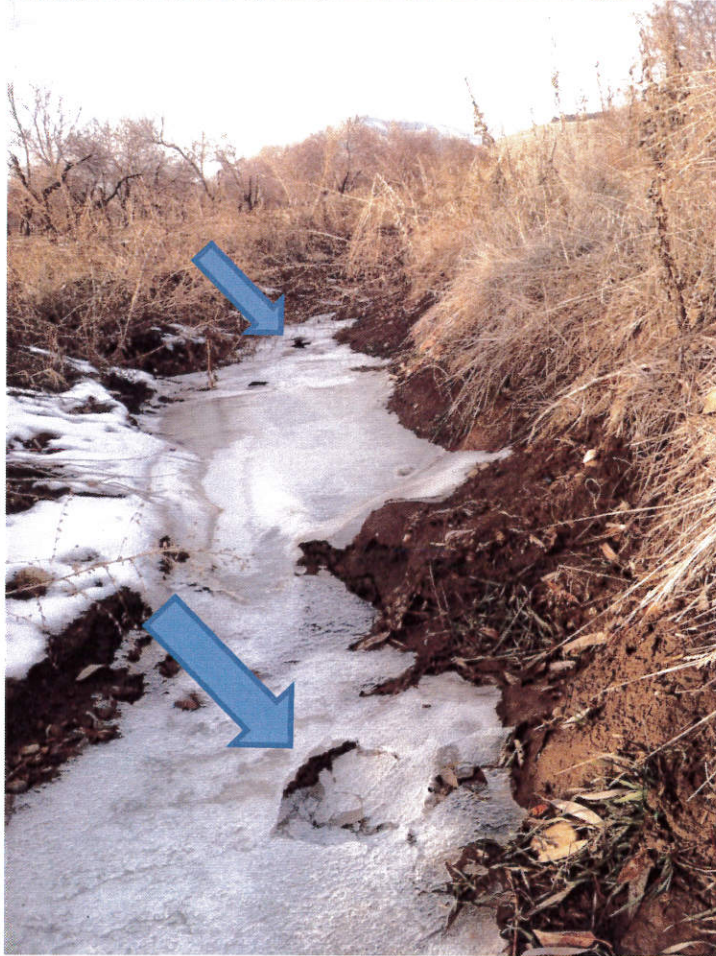
Looking north along natural runoff channel and flow path. No flowing water visible under the ice at 1630 hours (arrows indicate investigation points)

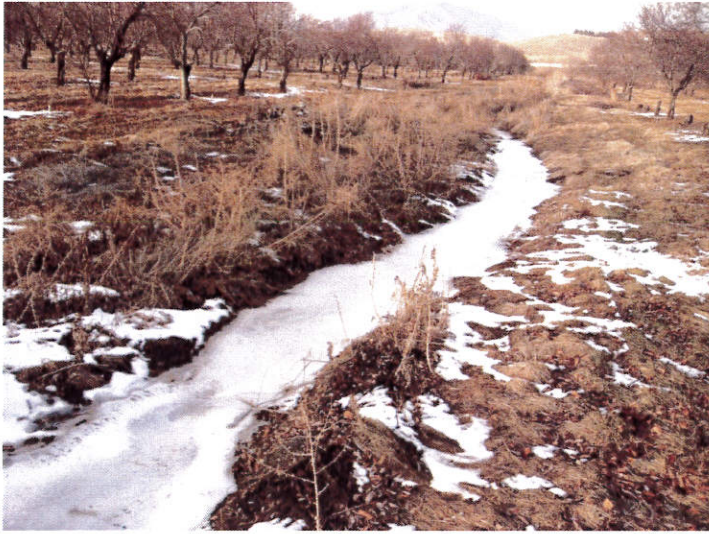
Looking north along natural runoff channel and flow path (approx. 720 feet FDP)

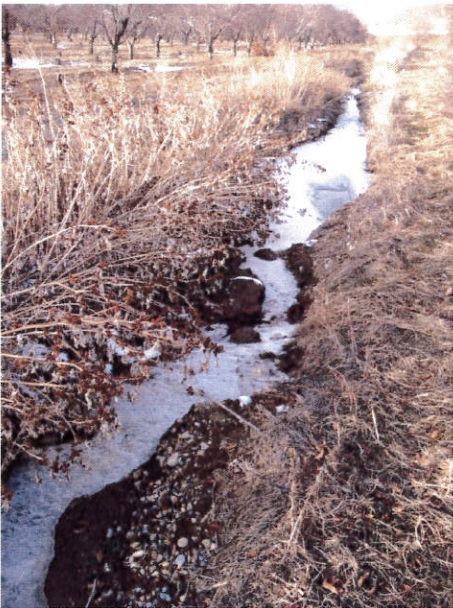
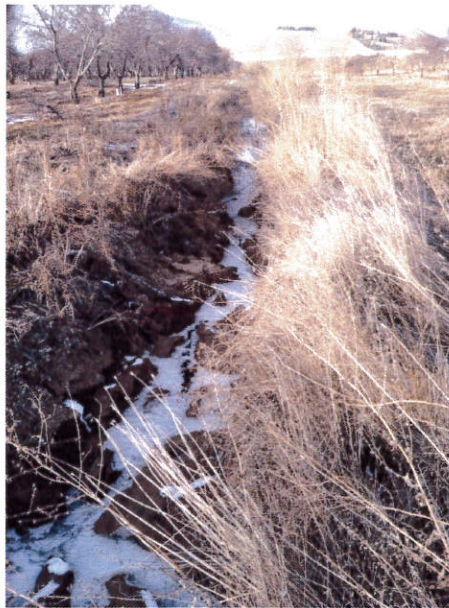
Looking north along natural runoff channel and flow path.

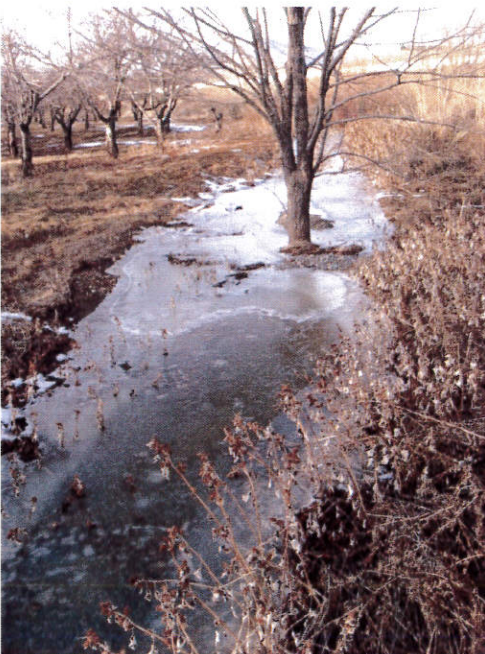
Area of pooling within the flow path, near the north end of Rowley's property (approx. 1230' from FDP)

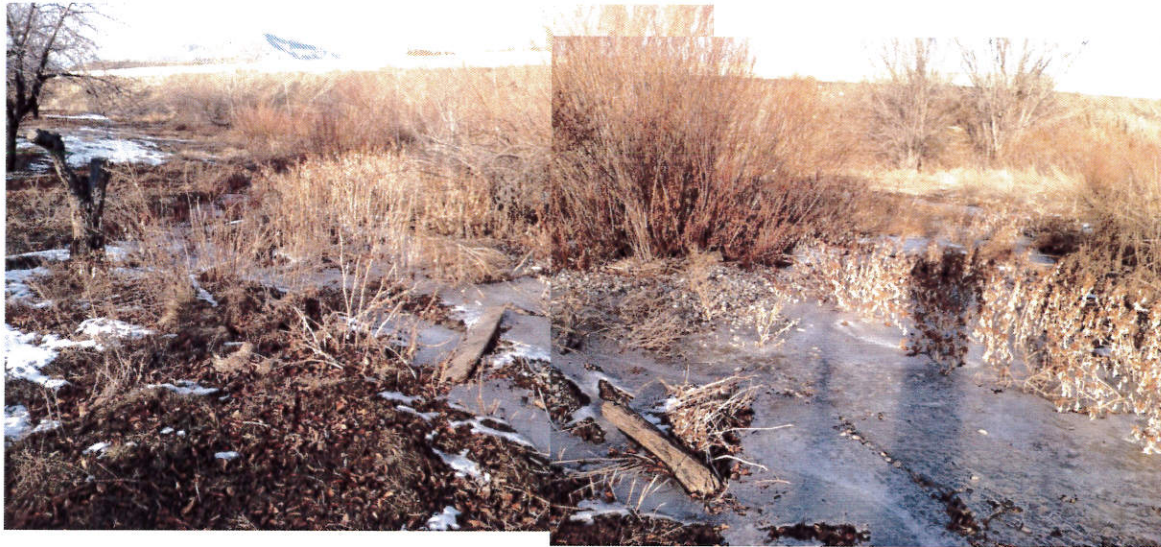
Looking north toward Highway 6 embankment. Flow begins braided stream pattern. No visible flow of water occurring under ice (approx. 1280 feet FDP).

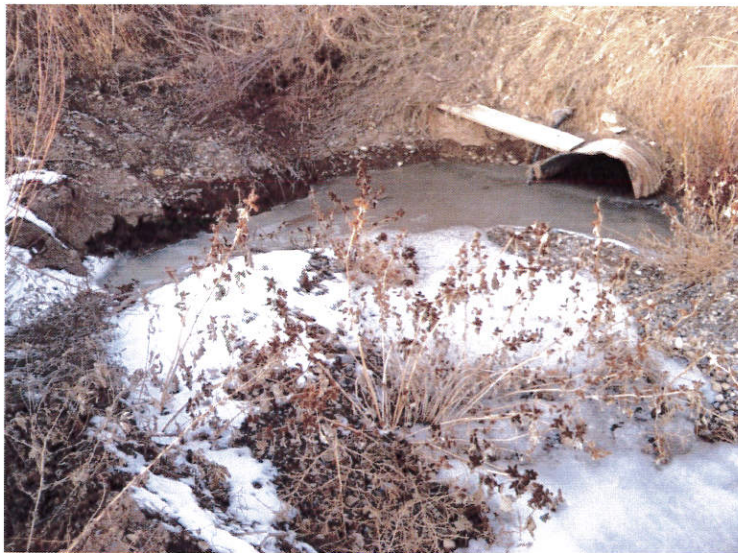
Seperated streams converge again at north property line and enters Highway 6 culvert. Area of pooling. Approx. 1390 feet FDP.

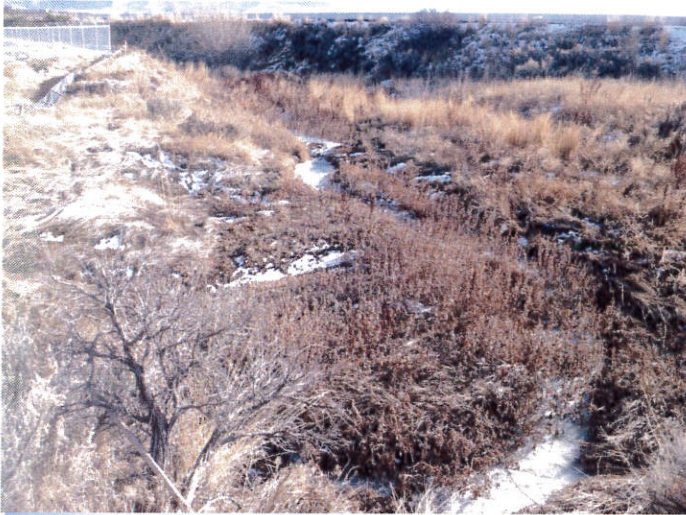
Looking south from Lark Lane toward Highway 6 embankment and along natural runoff channel.

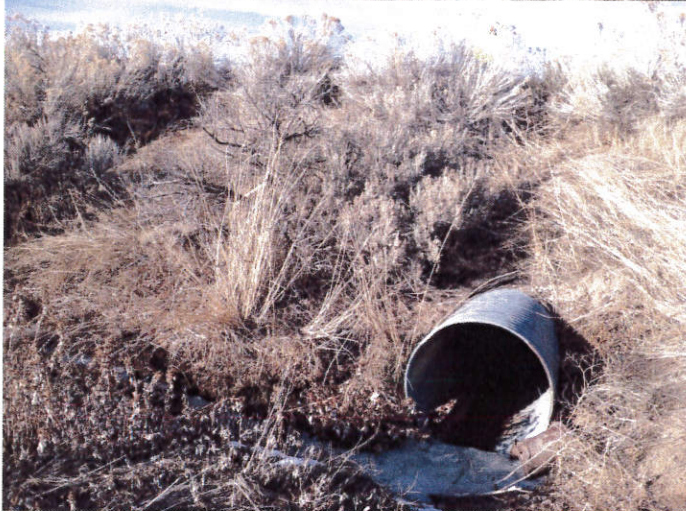
Looking north into runoff channel culvert under Lark Lane. Small amounts of flow happening in to the culvert. Picture taken around 1530 hours.

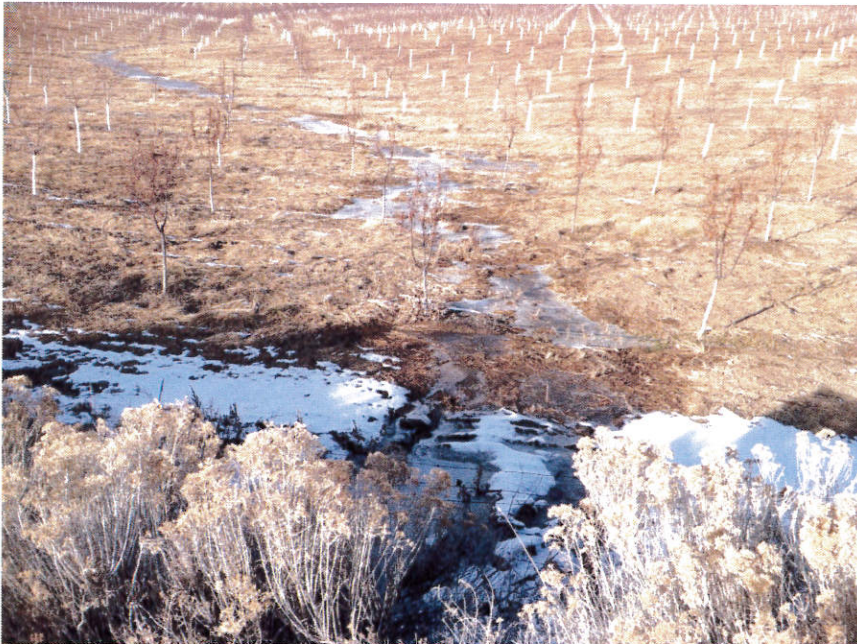
Looking north onto the Fowers' property and along the runoff course. Picture taken from Lake Lane road grade.

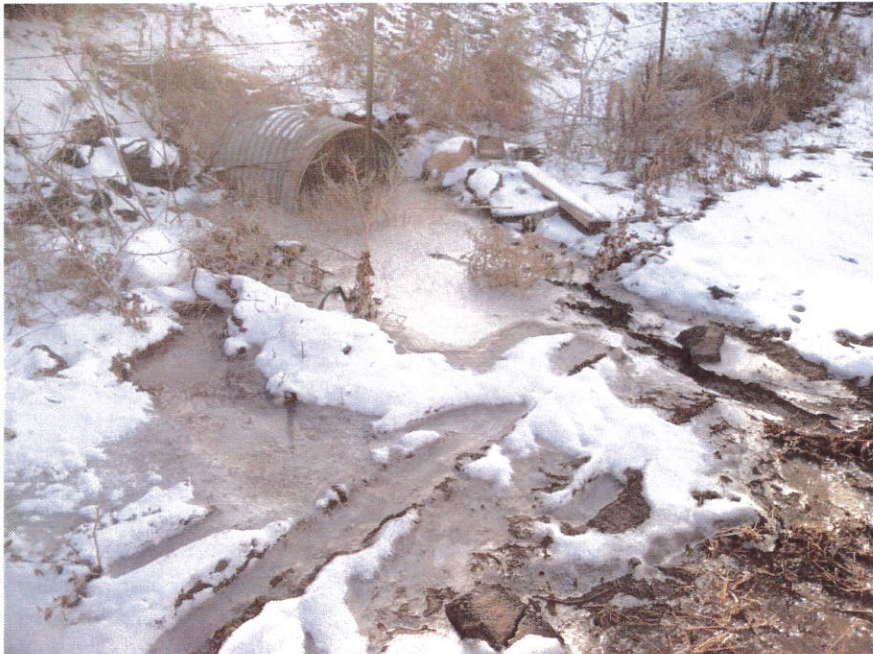
Discharged water flowing out of culvert and onto the Fowers' property.

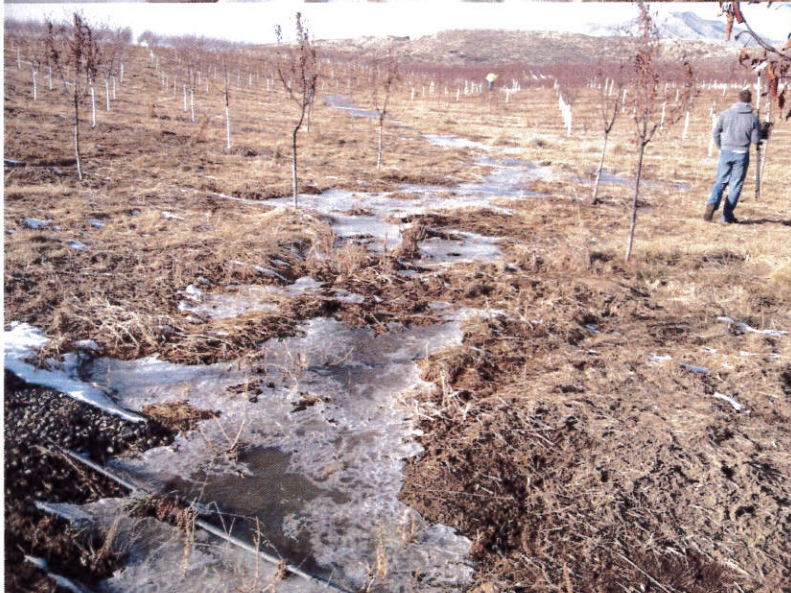
Looking north along flow path from culvert under Lark Lane.

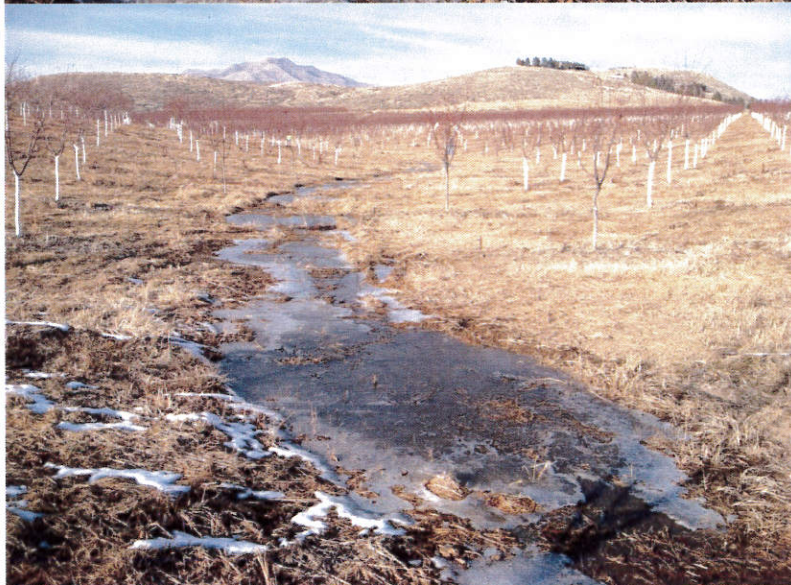
Looking northeasterly along flow path (approx. 230 feet from Lark Lane culvert; i.e. Fowers' south property line).

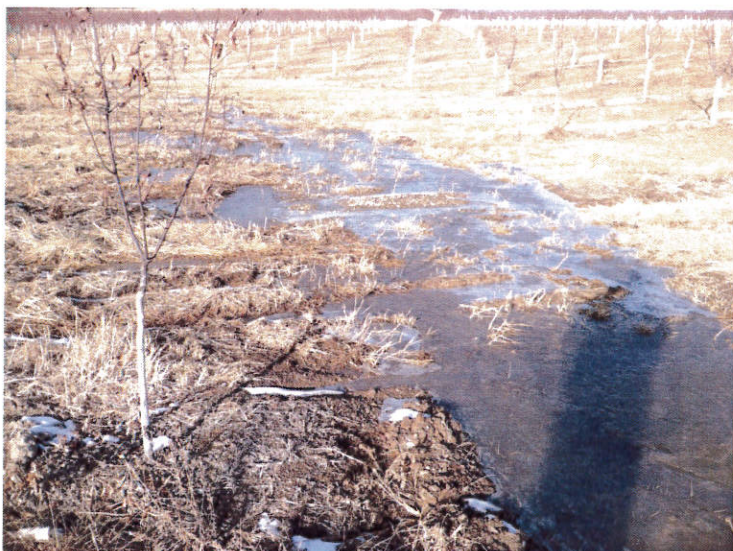
Looking northeasterly along flow path
(approx. 370 feet along the flow path
from Lark Lane culvert; i.e. Fowers' south
property line).

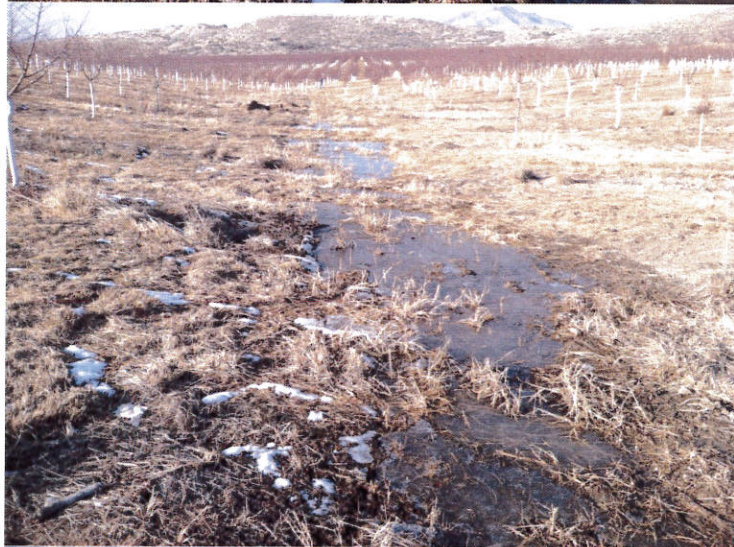
Looking northwesterly along flow path.
(Approx. 625 feet along flow path inside
Fowers' property.)

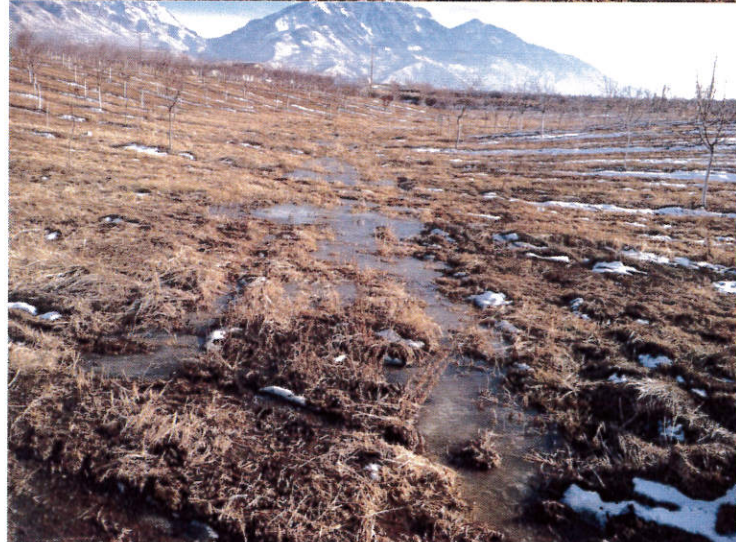
Looking southeasterly along the flow
path from same spot as previous picture.

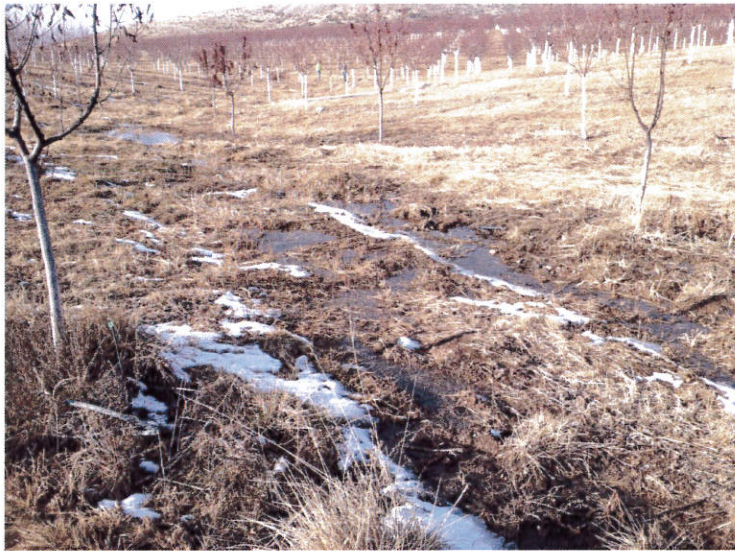
Looking northwesterly along flow path through Fowers' property (approx. 760 feet along path inside Fowers' property).

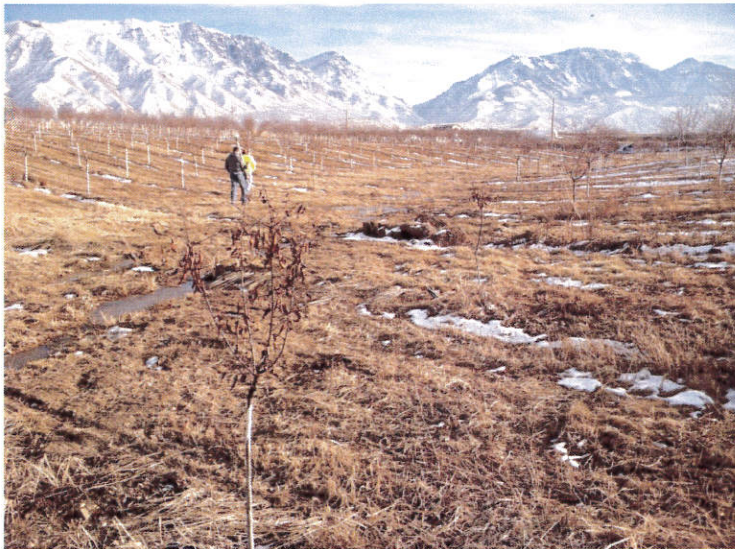
Looking southeasterly along flow path through Fowers' property (approx. 800 feet along path inside Fowers' property).

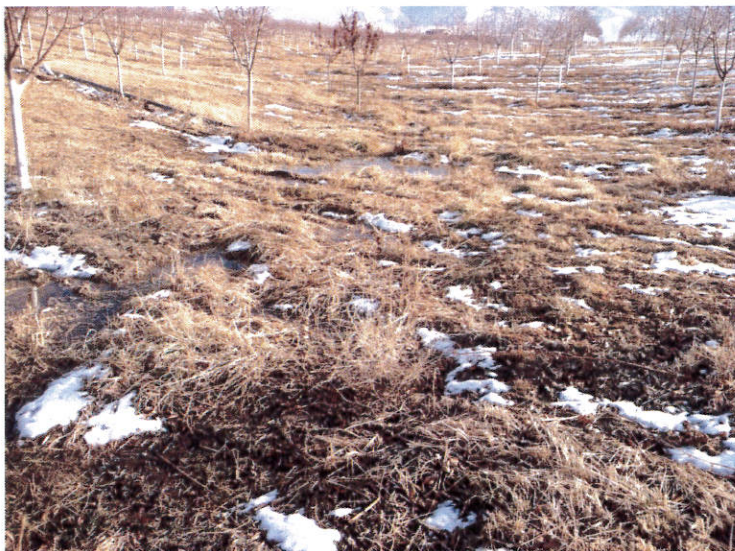
Looking southeasterly along flow path through Fowers' property (approx. 950 feet along path inside Fowers' property).

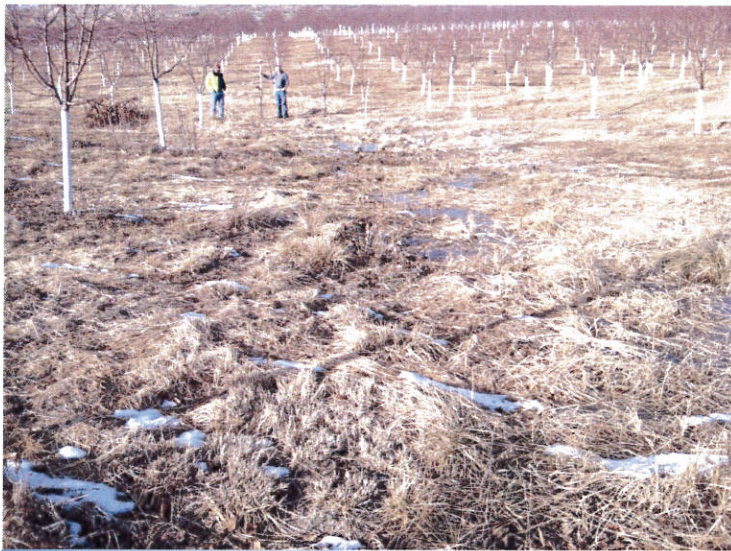
Looking northwesterly along flow path through Fowers' property (approx. 950 feet along path inside Fowers' property).

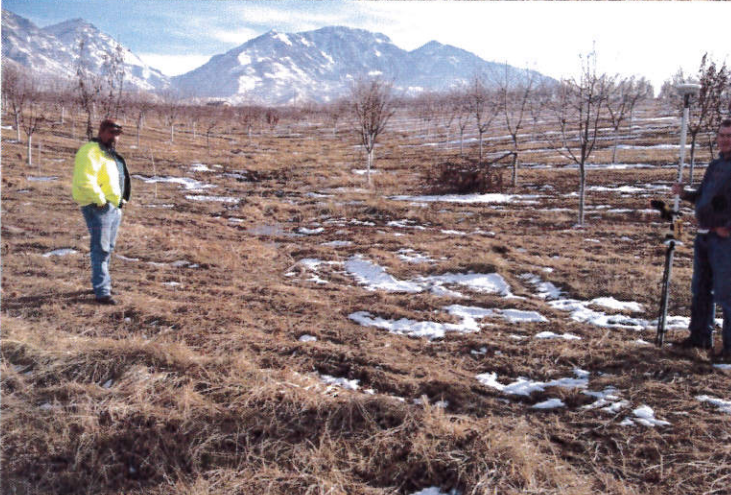
Wade Eva (left) and Greg Flint at flow terminus as of 1630 hours on January 10, 2012. Looking southeasterly.

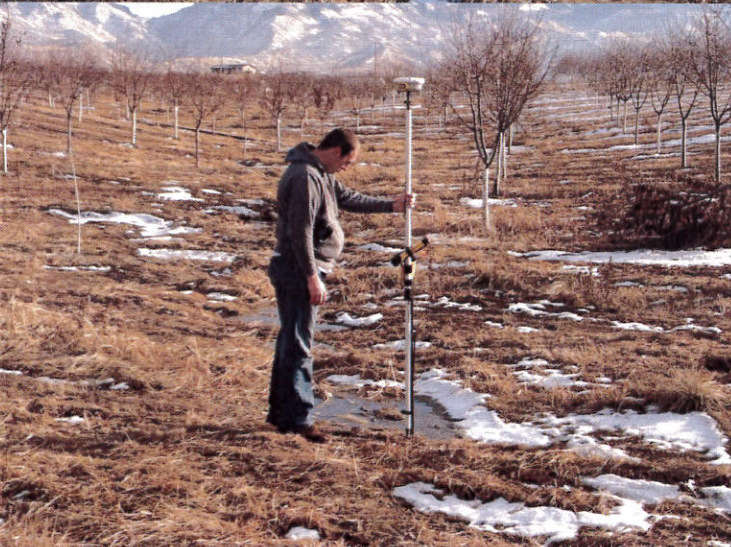
Greg Flint, surveying flow terminus as of 1630 hours on January 10, 2012. Approximately 1,025 feet along flow path from entrance onto Fowers' property. Approximately 2,850 feet from discharge point.

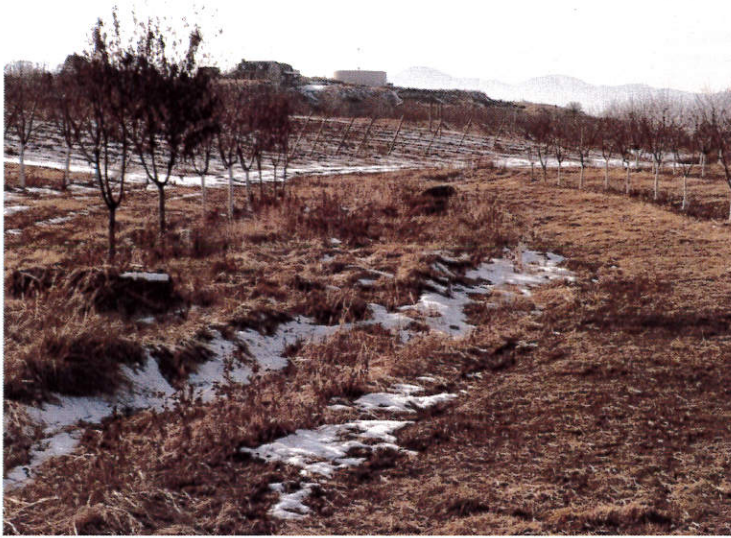
Looking west along anticipated direction of flow. As of 1630 on January 10, 2012 there was minor flow of water still occurring.

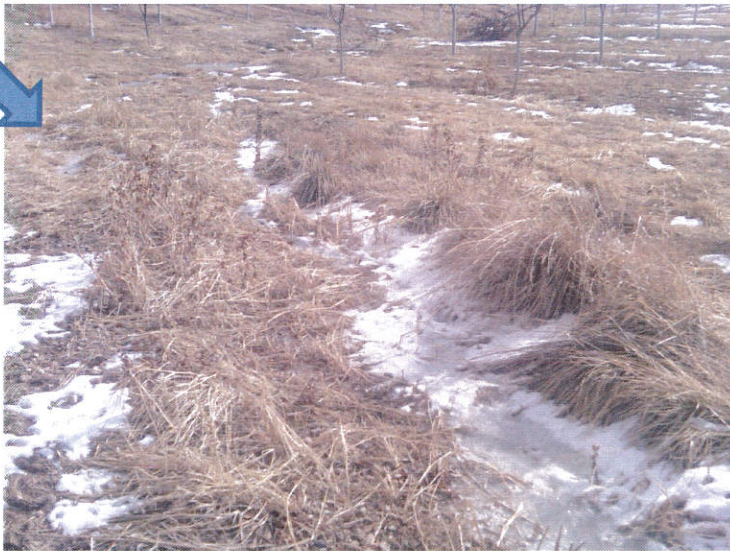
Picture taken January 11, 2012. Looking southeasterly toward surveyed flow terminus on January 10, 2012 (Indicated by arrow). Water has flowed as expected, through natural runoff channel.

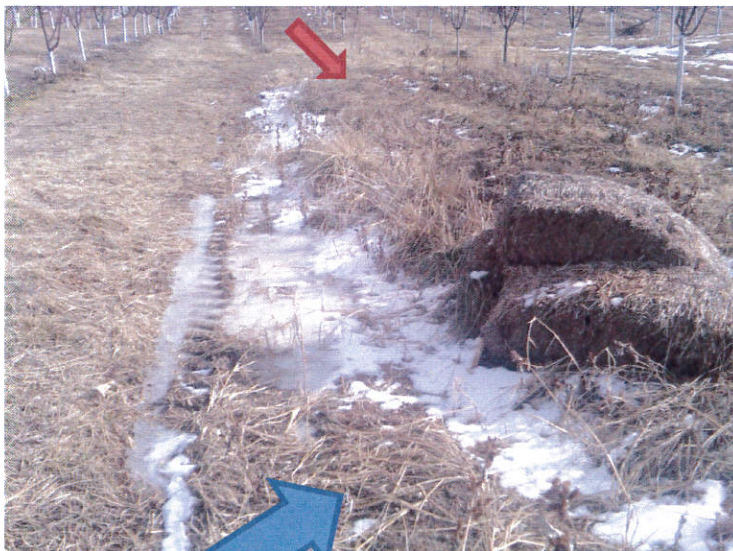
Looking westerly at new point of terminus (shown in foreground, blue) as of January 11, 2012, 1230 hours. There was no observed flowing of water along the flow path. Minimal expansion of flow path anticipated.

New point is approximately 100 feet west of previously surveyed point (shown in background, red)
